## TEST REPORT

Report No. : 11-07-EAT-054-E00  
Applicant : ALLIS COMMUNICATIONS CO., LTD.  
Address : 10-3Fl., No. 31-1, Lane 169, KangNing St., HsiChih  
District, New Taipei City, Taiwan  
Commodity : GPS ANTENNA  
Model : M type  
Quantity : 6 pcs  
Date of Receipt : Jul. 14, 2011  
Testing Item : 1. Thermal shock test  
2. Vibration test

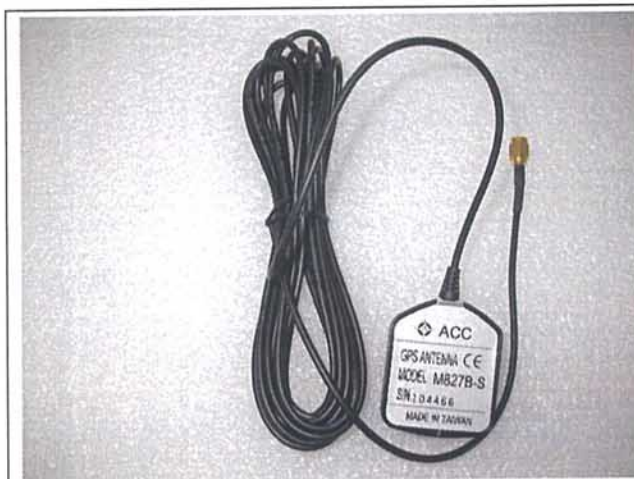
Fig. 1 : Sample condition

Sample condition : Refer to Fig. 1

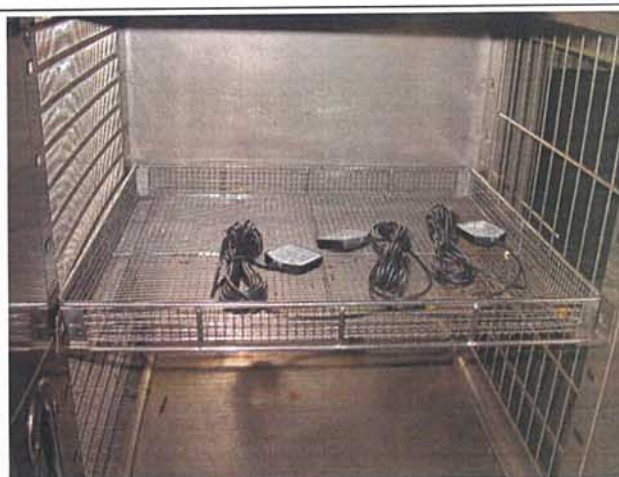
Fig. 2 : Thermal shock test

Test setup : Refer to Fig. 2

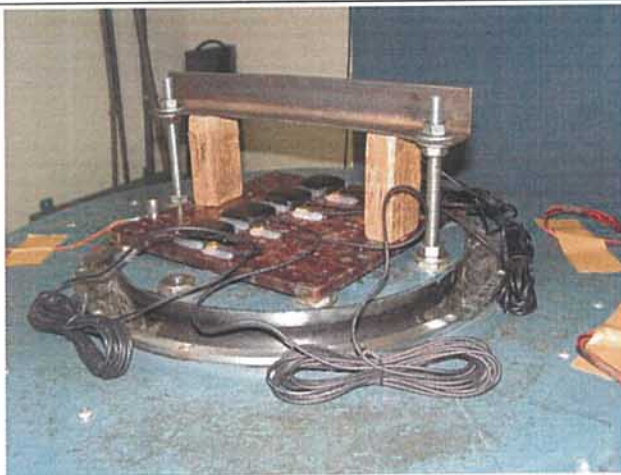
Fig. 3 : Vibration test (Z)

Sample condition : Non-operating (Refer to Fig. 3 ~ 8)

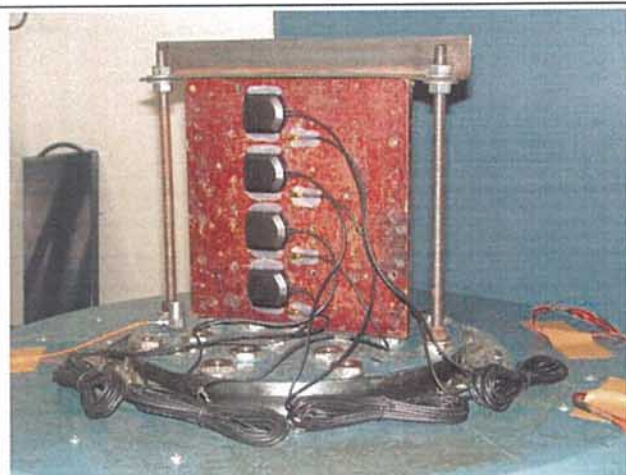
Fig. 5 : Vibration test (X)

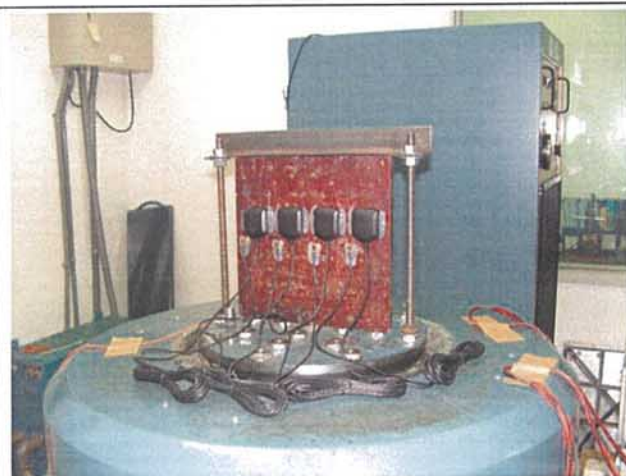
Fig. 7 : Vibration test (Y)
